**Sebert Trillingstechniek B.V.**

Report M21.001-P21.001 Zepcam  
Date 16 November 2021

## Drop tests on six body cameras according to test standard MIL-STD 810G

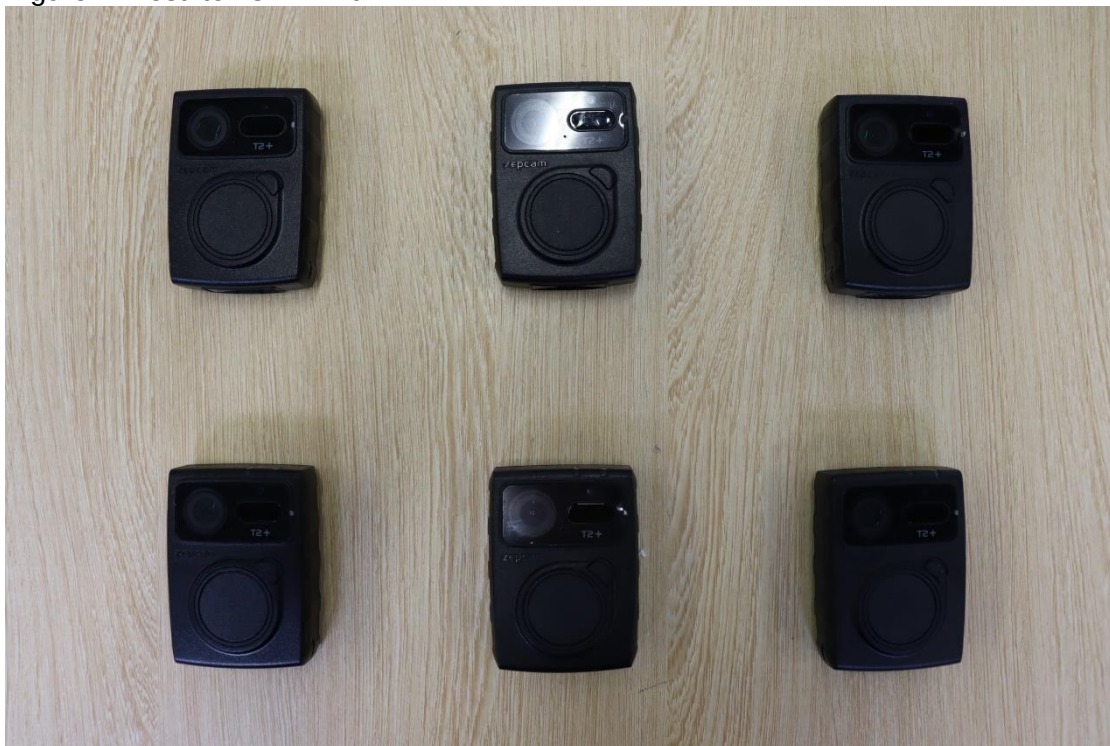
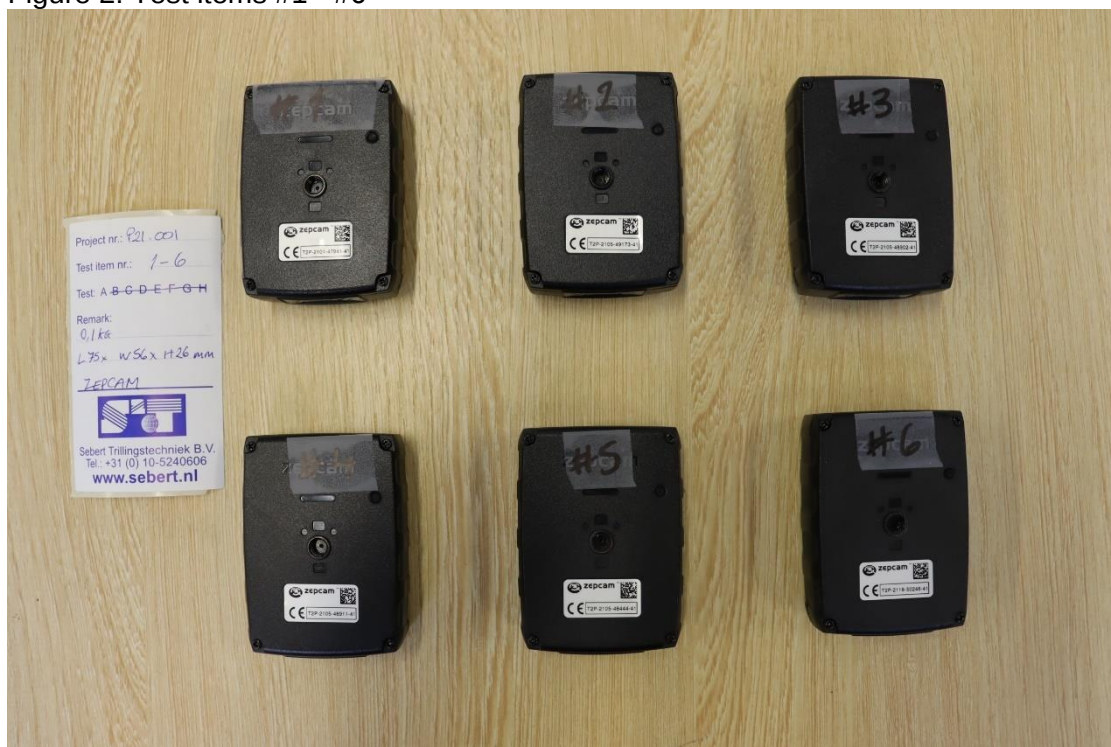
Figure 1: Test items #1 - #6

Figure 2: Test items #1 - #6

Six test items have been used for the transport simulation tests, see Table 1A -1F for the details of the test items. The ASTM D 5276-98 (2004) procedure has been used for identification of the faces of the test items, see Figure #3. The test items which were delivered on 12 November 2021 were checked before starting the test for visual damage and no deviations were found.

| Figure | #1 and #2 |

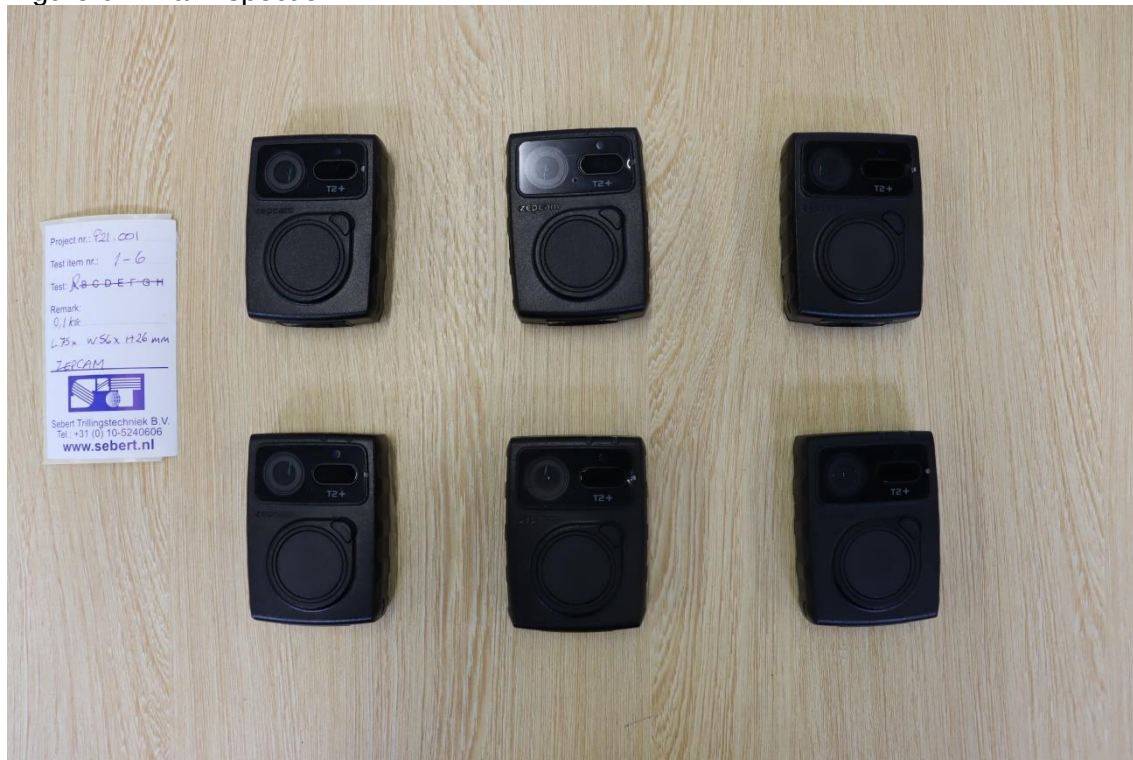
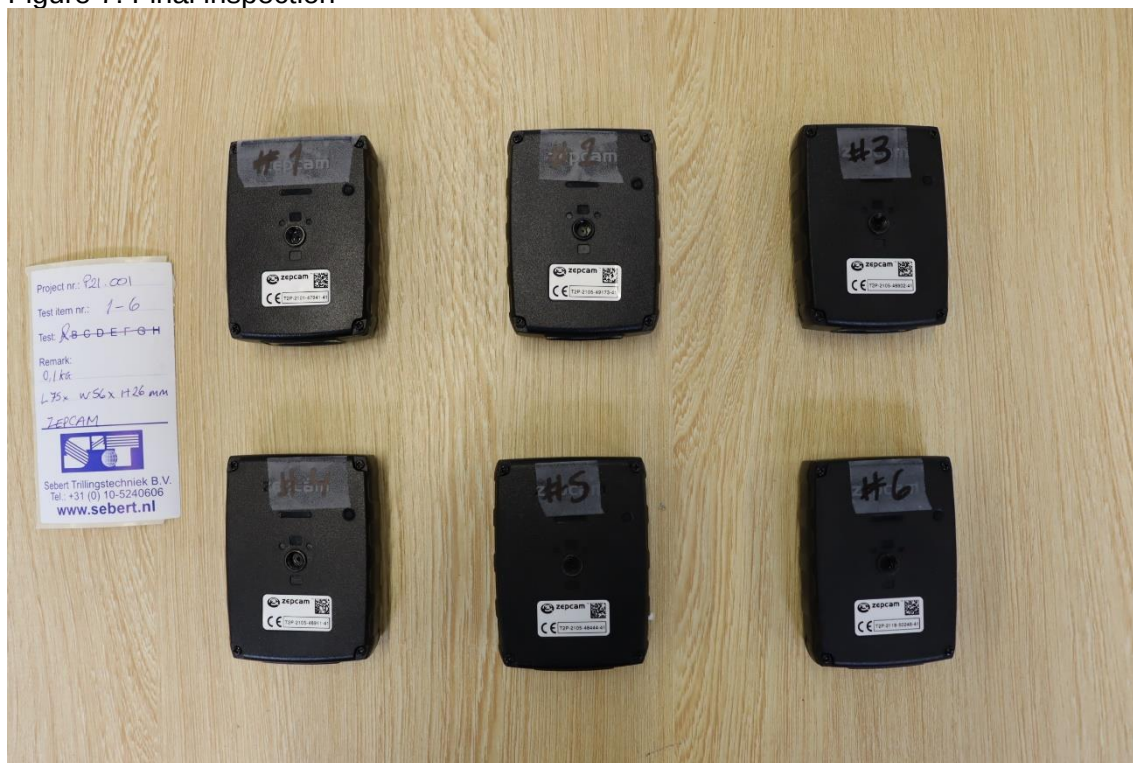
Figure 6: Final inspection

Figure 7: Final inspection

| Test item | Results/remarks | Figure |
|---|---|---|
| #1 | Small indentation on the corner of 3-4-6 | #6 to #11 |

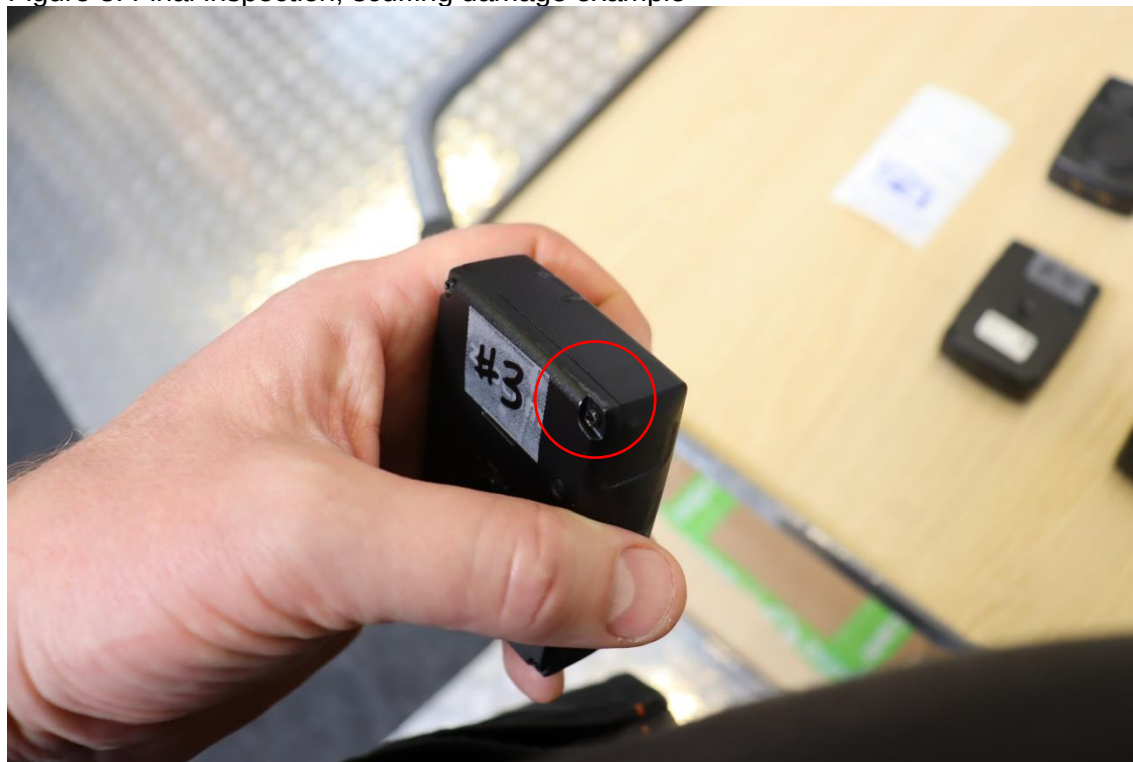
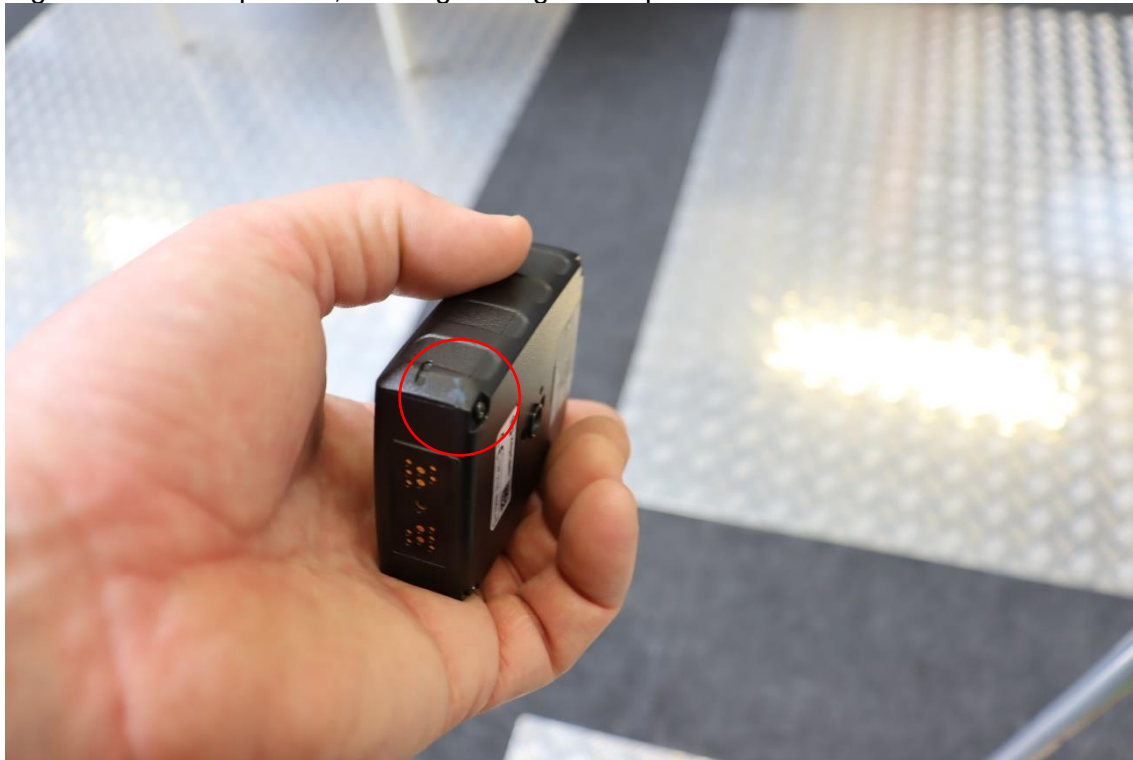
Figure 8: Final inspection, scuffing damage example

Figure 9: Final inspection, scuffing damage example

| Test item | Results/remarks | Figure |
|---|---|---|
| #3 | Slight scuffing and small indentation of corner 3-4-5 | |
| #5 | Small area of scuffing damage on side 4 | |

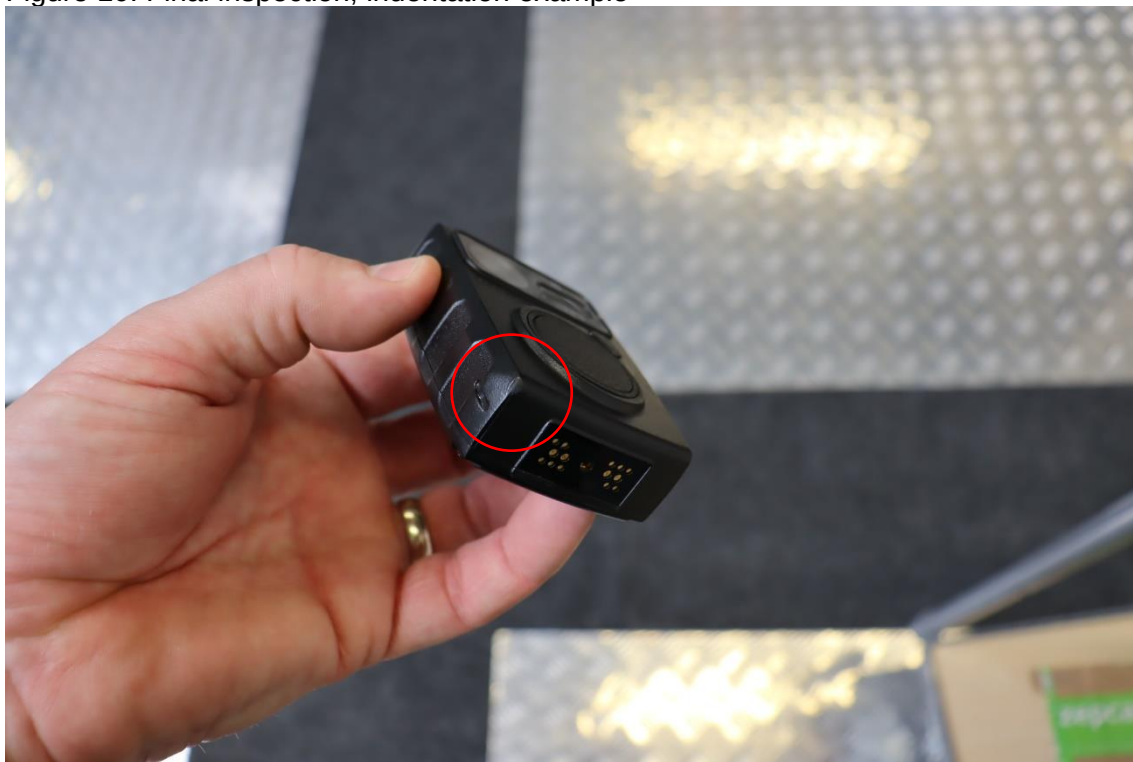
Figure 10: Final inspection, indentation example

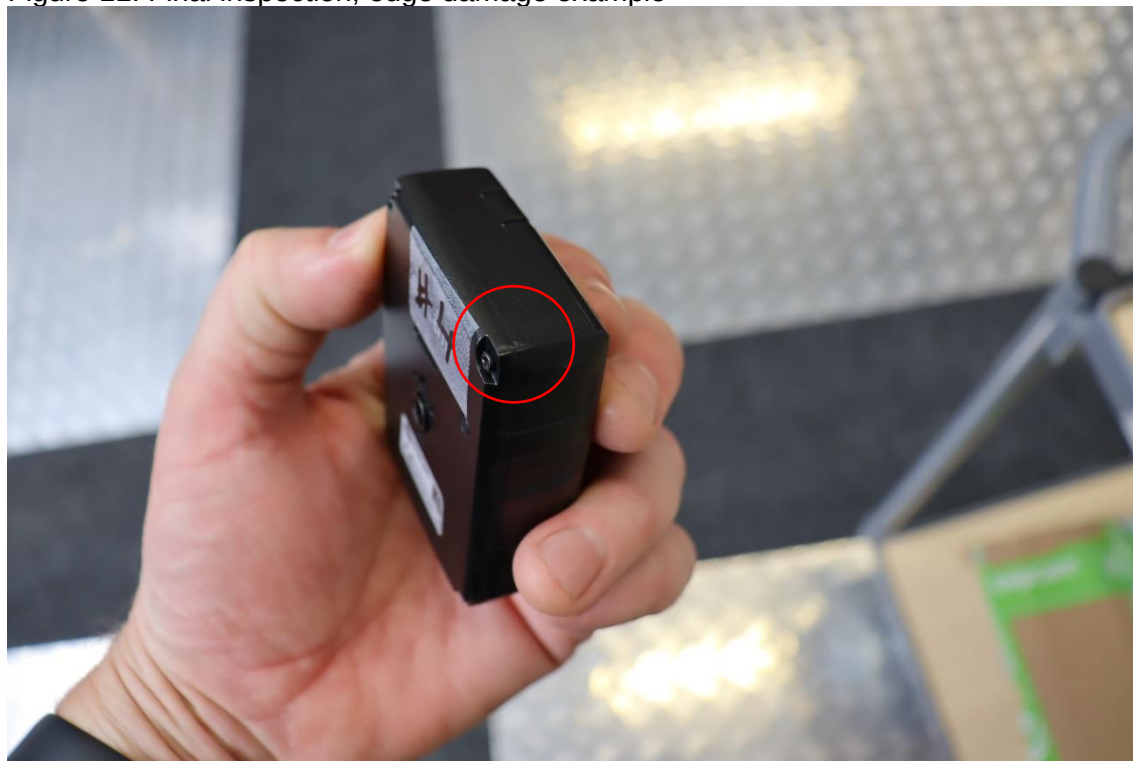
Figure 11: Final inspection, edge damage example

| Test A:<br>Drop test | All test items continued to function normally throughout the test sequence. Only minor scuffing and impact marks were detected. |
